## **HYDRANT FLOW TEST ANALYSIS REPORT 2005**

PREPARED BY MICHAEL KRETSCHMANN, PE

FIRE PROTECTION ENGINEERING GROUP

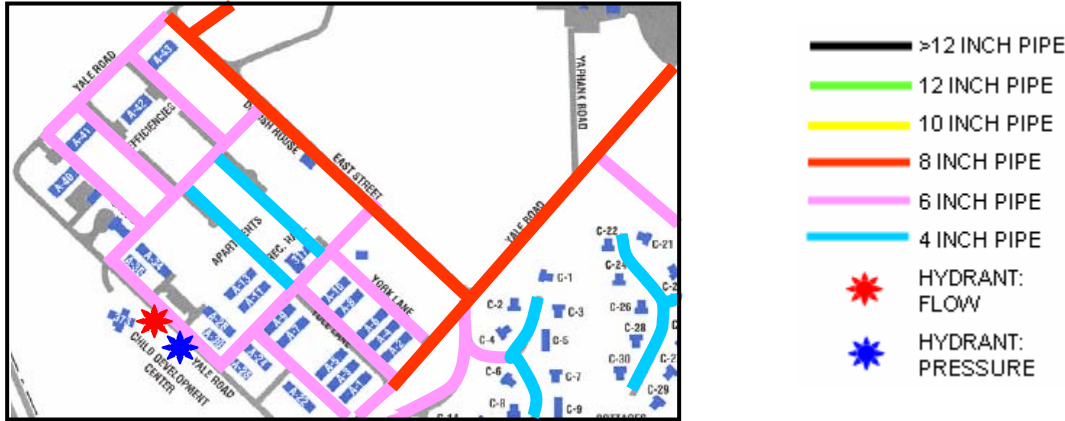
#### 4.1 TEST POINT 1: APARTMENTS

MEFF 1,500 GPM	OCCUPANCY ORDINARY HAZARD	PIPING CONDITION POOR	FLOW CAPACITY POOR	PIPING NETWORK DEAD END
-------------------	------------------------------	--------------------------	-----------------------	----------------------------

**Piping Condition** is rated "Poor" since the flow trend is losing capacity at roughly 8% over the last 15 years.

**Piping Network** of water supplies is rated "Dead End" since all water must enter via the isolated 8 inch loop. The two six inch feeds along Princeton Ave. have to be investigated to see if can support the area by themselves.

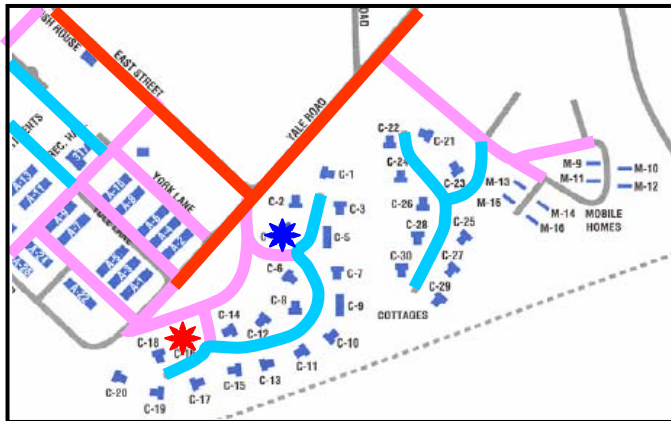
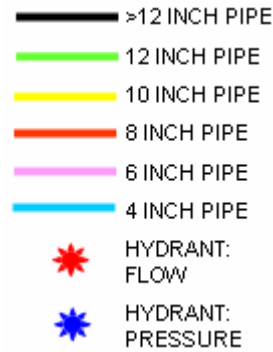
## 4.2 TEST POINT 2: COTTAGES

MEFF 1,500 GPM	OCCUPANCY ORDINARY HAZARD	PIPING CONDITION POOR	FLOW CAPACITY POOR	PIPING NETWORK DEADEND
-------------------	------------------------------	--------------------------	-----------------------	---------------------------

**Piping Condition** is rated "Poor" since the flow trend is losing capacity.

**Piping Network** of water supplies is rated "Dead End" since all water must enter via the isolated 8 inch loop. The two six inch feeds along Princeton Ave. have to be investigated by hydraulic modeling to see if can support the area by themselves.

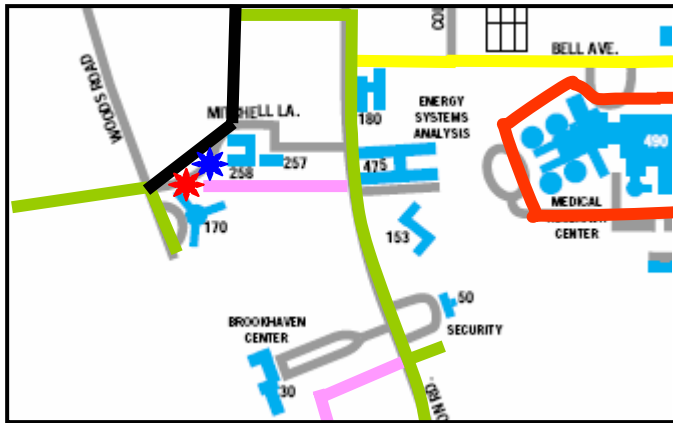
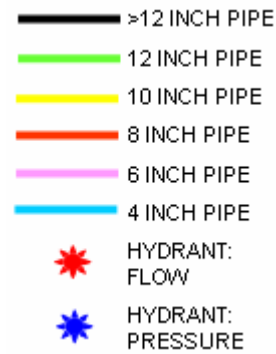
### 4.3 TEST POINT 3: GUEST HOUSE / CURIE- WOMEN'S RESIDENCE

MEFF 750 GPM	OCCUPANCY LOW HAZARD	PIPING CONDITION FAIR	FLOW CAPACITY LIMITED	PIPING NETWORK DEAD END
-----------------	-------------------------	--------------------------	--------------------------	----------------------------

**Piping Condition** is rated "Fair" since the flow trend is losing capacity at roughly 3% over the last 15 years.

**Piping Network** of water supplies is rated "Dead End" since it gets the majority of water from the 300K storage tank located in close proximity to the hydrants. It will have to be investigated by hydraulic modeling to see if by eliminate the 300K storage tank as a source that the Residences will have adequate flow and pressure.

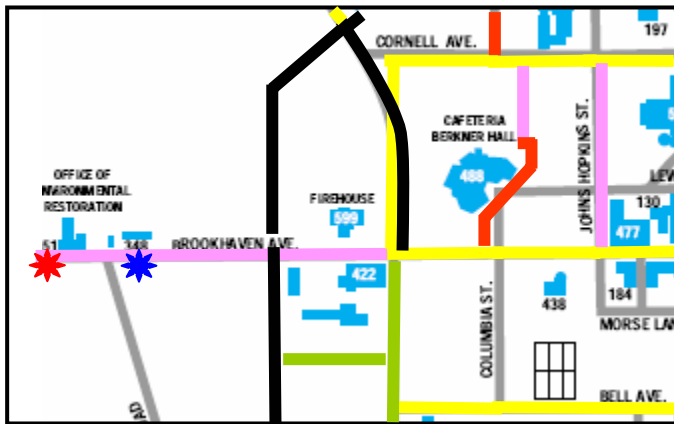
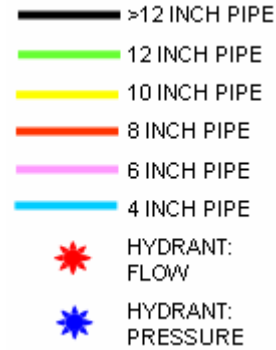
#### 4.4 TEST POINT 4: WEST BROOKHAVEN AVENUE

MEFF 1,000 GPM	OCCUPANCY HIGH HAZARD	PIPING CONDITION FAIR	FLOW CAPACITY POOR	PIPING NETWORK DEAD END
-------------------	--------------------------	--------------------------	-----------------------	----------------------------

**Piping Condition** is rated "Fair" since the flow trend is losing capacity at roughly 2% over the last 15 years.

**Piping Network** of water supplies is rated "Dead End" since it gets water from single line connection

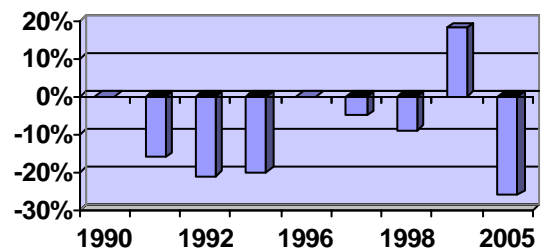
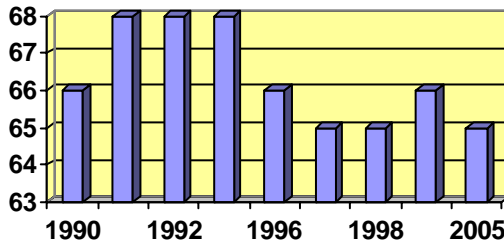
The pressure hydrant was H132 and the flow hydrant H133. The nearest water supply source (1,000K Tank) is about 1,800 feet away. The local loop mains are 6 inch. The piping in this area has not been altered since the first relevant flow test in 1990 and is over 60 years old. The piping is Transite Cement Lined.

**Occupancy** is rated "High Hazard" due to large fire loads (fuel oil tank storage, wood frame buildings).

**Piping Condition** is rated "Good" due to the current year results were close to the water model output for the pressure hydrant. C factor used in model would support a "Good" rating.

**Piping Network** of water supplies is rated "Multiple Path" since can easily get water from multiple sources around the site.

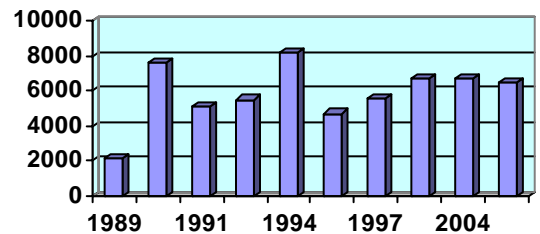
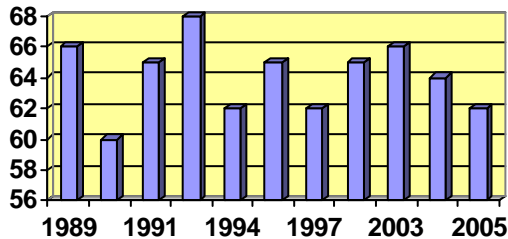
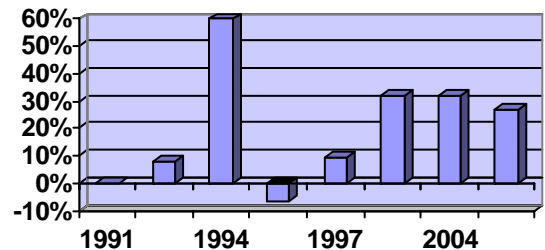
#### 4.11 TEST POINT 11: EAST CORNELL AVENUE

The pressure hydrant was H113 and the flow hydrant H114. The nearest water supply source (Water Treatment Facility) is about 3,000 feet away. The local mains are 10 inch. The piping in this area has not been altered since the first relevant flow test in 1989 and is over 60 years old. The piping is Transite Cement Lined. . .

**Occupancy** is rated "High Hazard" due to large fire loads (HFBR, CFN studies and wood roof in building 480).

**Piping Condition** is rated "Good" due to an increase in available flow by 11% in the last 14 years.

**Piping Network** of water supplies is rated "Multiple Path" since can easily get water from multiple sources around the site.

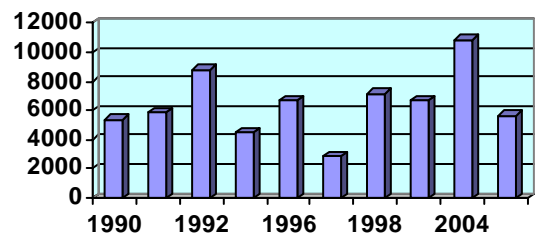
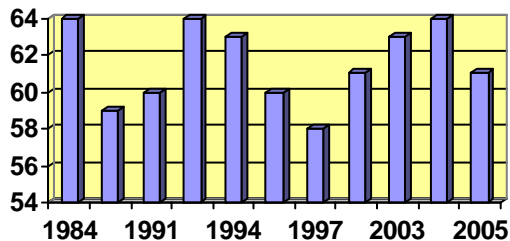
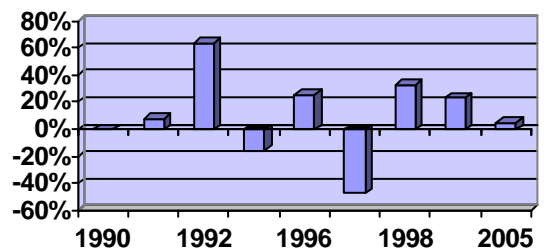
**4.12 TEST POINT 12: RAILROAD ST. & RUTHERFORD AVE.**

The pressure hydrant was H141 and the flow hydrant H138. The nearest water supply source (Well 10) is about 1,200 feet away. The local mains are 10 inch. The piping in this area has not been altered since the first relevant flow test in 1990 and is about 50 years old. The piping is Transite Cement Lined and may consist of other unidentified materials.

For Analysis we have eliminated 2004 test results because the results are almost twice the average flow over the last 15 years. The average available flow is now about 6,100 GPM. Average flow rate from 1990 has increased by up to 3.2%. This flow rate increase cannot be explained by apparent changes in either piping condition or day to day water demands

**Occupancy** is rated "High Hazard" due to large fire loads (Flammable liquid storage in chemical labs in building 815, hot cells in Building 830).

**Piping Condition** is rated "Good" due to an increase in available flow by 15% in the last 15 years.

**Piping Network** of water supplies is rated "Multiple Path" since can easily get water from multiple sources around the site.

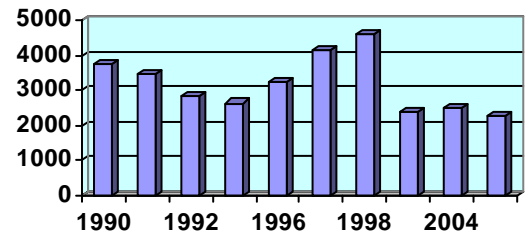
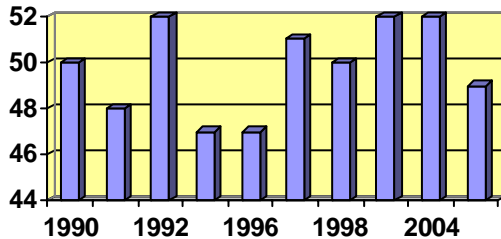
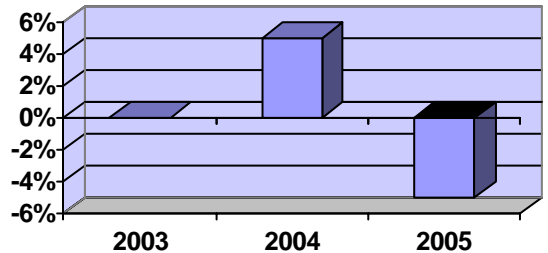
### 4.13 TEST POINT 13: RUTHERFORD DRIVE

The pressure hydrant was H144 and the flow hydrant H247. The nearest water supply source (Well 10) is about 2,200 feet away. The local loop mains are 10 inch. The piping in this area was originally fed from four directions. One feed was eliminated when building 906 was built in the 1980's. The second feed, under building 912, was closed in January 2002 due to activation concerns of the potable water by beam lines. The piping is Cast Iron and may consist of other unidentified materials.

**Occupancy** is rated "High Hazard" due to large fire loads (HFBR).

**Piping Condition** is rated "Fair" due to type of material in the area.

**Piping Network** of water supplies is rated "Multiple Path" since can easily get water from multiple sources around the site.

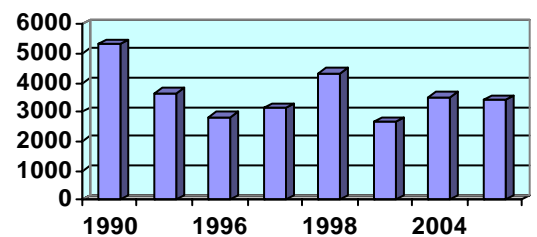
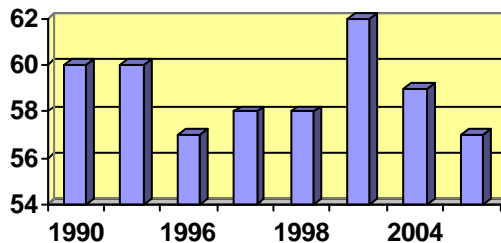
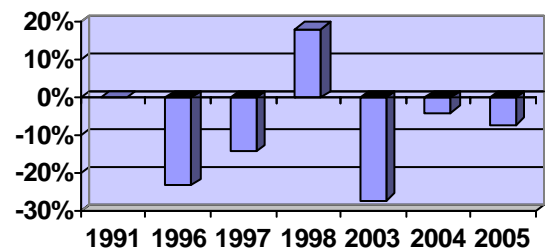
## 4.14 TEST POINT 14: COSMOTRON ROAD

The pressure hydrant was H043 and the flow hydrant H205. The nearest water supply source (Water Treatment Facility) is about 3,900 feet away. The local loop mains are 8 inch. The piping in this area has not been altered since the first relevant flow test in 1990 and is about 40 years old. The piping in this area is Transite Cement Lined and may consist of other unidentified materials.

**Occupancy** is rated "High Hazard" due to large fire loads (combustible roof on building 902).

**Piping Condition** is rated "Good" due to the recent flow trend is similar to a new pipe.

**Piping Network** of water supplies is rated "Multiple Path" since can easily get water from multiple sources around the site.

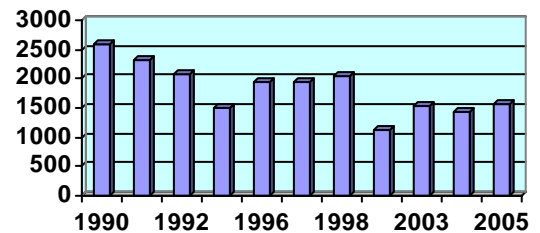
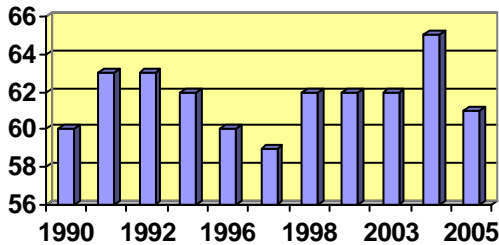
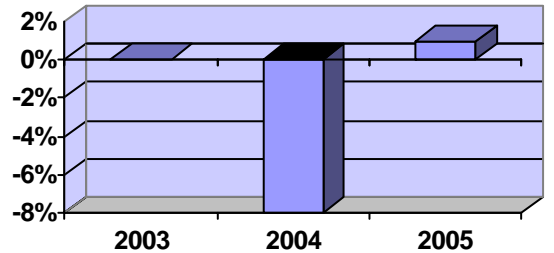
#### 4.15 TEST POINT 15: COCKCROFT STREET

The pressure hydrant was H166 and the flow hydrant H168. The nearest water supply source (Water Treatment Facility) is about 3,900 feet away. The dead end main is 6 inch. The piping in this area was a 6 inch loop main that went under building 912 due to activation concerns of the potable water by beam lines in building 912. Main was closed in January 2002. The piping is about 40 years old. The piping is Transite Cement Lined and may consist of other unidentified pipe types.

Static pressures have remained relatively consistent (~62 PSI.) The consistent readings can be attributed the large diameter grid supply piping network. These constant static pressure readings cannot be explained by apparent changes in either piping condition or day to day water demands. Further investigation by means of a hydraulic flow model study is required to understand the trend.

**Occupancy** is rated "High Hazard" due to large fire loads (cable trays in building 912, wood frame support buildings).

**Piping Condition** is rated "Good" since water model has similar results and it is using a pipe roughness factor is close to a new pipe,

**Piping Network** of water supplies is rated "Dead End" since this area can only get water via the small dead end pipe to the water sources.

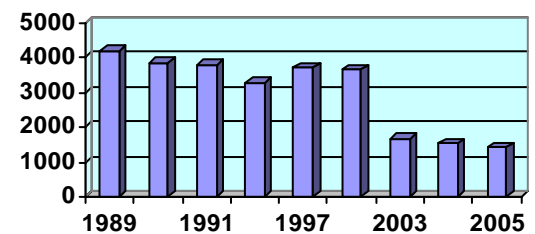
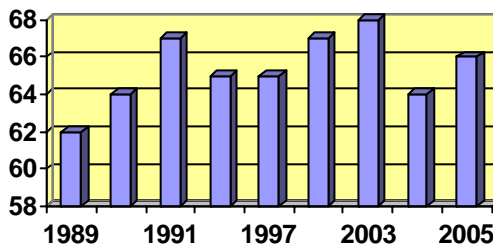
#### 4.16 TEST POINT 16: LAWRENCE DRIVE

**Occupancy** is rated "High Hazard" due to large fire loads (AGS warehouses, multistory buildings).

**Piping Condition** rated "Poor" since the flow trend is losing capacity at roughly 15% over the last 3 years.

**Piping Network** of water supplies is rated "Dead End" concern since this area can only get water via the single length of pipe to the water sources.

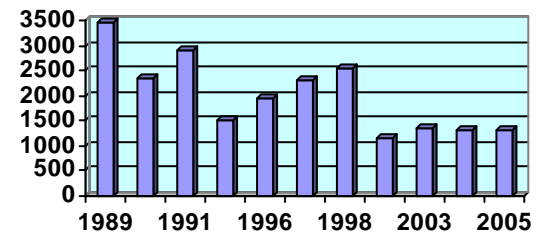
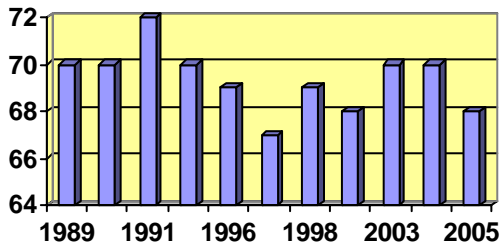
#### 4.17 TEST POINT 17: EAST OF BUILDING 912

Static pressures have remained relatively consistent (~69 PSI). These constant static pressure readings cannot be explained by apparent changes in either piping condition or day to day water demands. Further investigation by means of a hydraulic flow model study is required to understand the trend.

**Occupancy** is rated "High Hazard" due to large fire loads (target halls for AGS, large AGS buildings).

**Piping Condition** rated "Poor" since the flow trend is losing capacity at roughly 2% over the last 3 years.

**Flow Capacity** is rated as "Poor" because of the limited flow rate at current piping conditions.

**Piping Network** of water supplies is rated "Dead End" since this area can only get water via the small dead end pipe to the water sources.

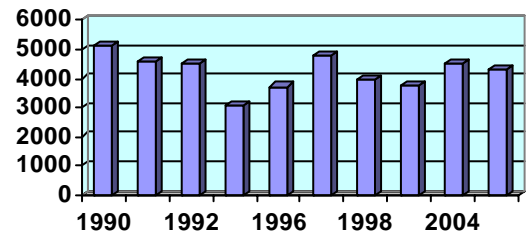
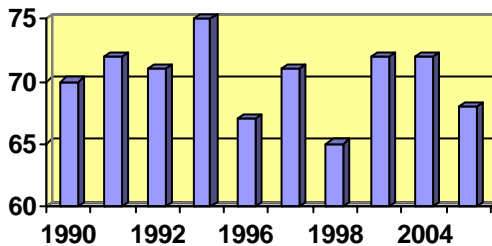
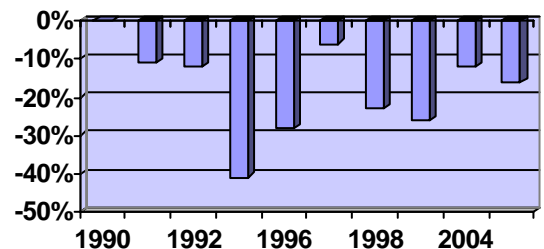
#### 4.18 TEST POINT 18: WEST FIFTH AVENUE

The pressure hydrant was H202 and the flow hydrant H201. The nearest water supply source (Water Treatment Facility) is about 2,500 feet away. The local loop mains are 8 inch while the feed from the Water Treatment Facility is 10 inch. The piping in this area has not been altered since the first relevant flow test in 1990 and is about 40 years old. The piping is Transite Cement Lined and Black Steel.

**Occupancy** is rated "Ordinary Hazard" due to non combustible buildings with combustible contents, cable trays.

**Piping Condition** is rated "Good" due to a decrease in available flow less than 2% in the last 15 years.

**Piping Network** of water supplies is rated "Multiple Path" since this area can easily get water from multiple sources around the site.

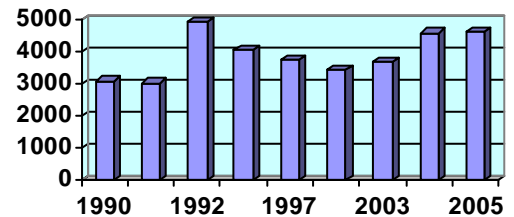
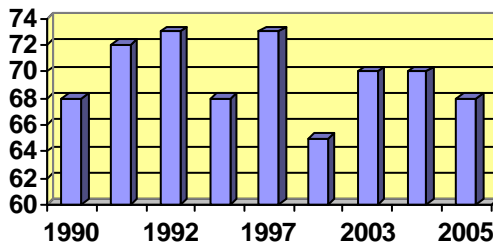
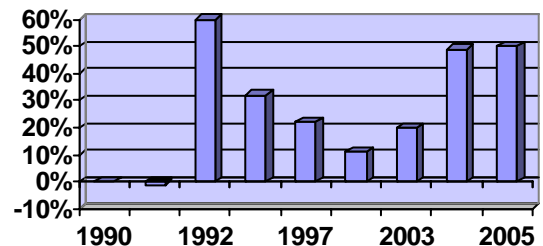
#### 4.19 TEST POINT 19: THOMPSON AVENUE

The pressure hydrant was H234 and the flow hydrant H211. The nearest water supply source (Well 10) is about 2,600 feet away. The local mains are 8 inch. The piping has not been altered since the first relevant flow test in 1990 and is about 40 years old. The piping is Transite Cement Lined and Cast Iron.

**Occupancy** is rated "Ordinary Hazard" due to non combustible buildings with combustible contents.

**Piping Condition** is rated "Good" due to a increase in available flow of 9% in the last 15 years.

**Piping Network** of water supplies is rated "Multiple Path" since this area can easily get water from multiple sources around the site.

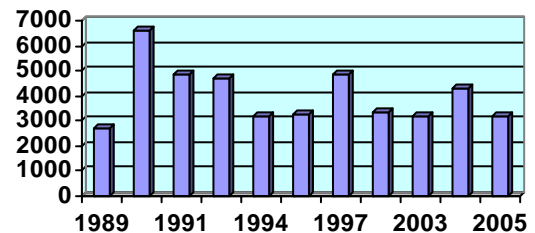
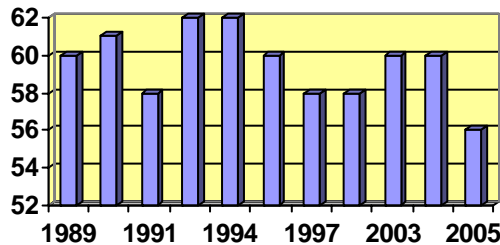
## 4.20 TEST POINT 20: WEST PRINCETON AVENUE

**Occupancy** is rated "Ordinary Hazard" due to the wood frame buildings with flammable liquids, but low importance to BNL programs.

**Piping Condition** is rated "Poor" due to a decrease in available flow by 12% in the last 16 years.

**Piping Network** of the water supplies is rated "Multiple Path" since this area can easily get water from multiple sources around the site.

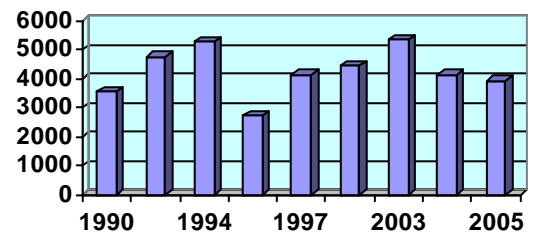
CALCULATED FLOW AT 20 PSI (GPM)

The average available flow is now about 4,400 GPM. Average flow rate from 1990 has increased by up to 4%. This flow rate increase cannot be explained by apparent changes in either piping condition or day to day water demands.

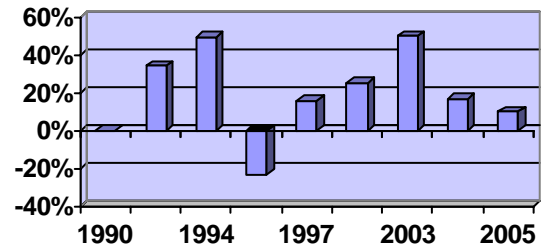
PERCENT FLOW CHANGE FROM 1990

**Piping Condition** is rated "Good" due to an increase in available flow by 11% in the last 13 years.

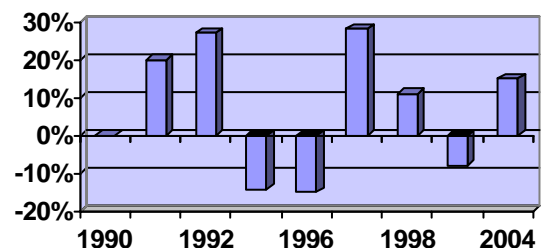
PERCENT CHANGE FROM BASE

**Piping Condition** is rated "Good" due the available flow has been relatively stable in the last 15 years.
